**TERRAMIN AUSTRALIA LIMITED**

**ANGAS MINE**

**ENVIRONMENTAL MONITORING PORGRAM**

**QUATERLY REPORT #2**

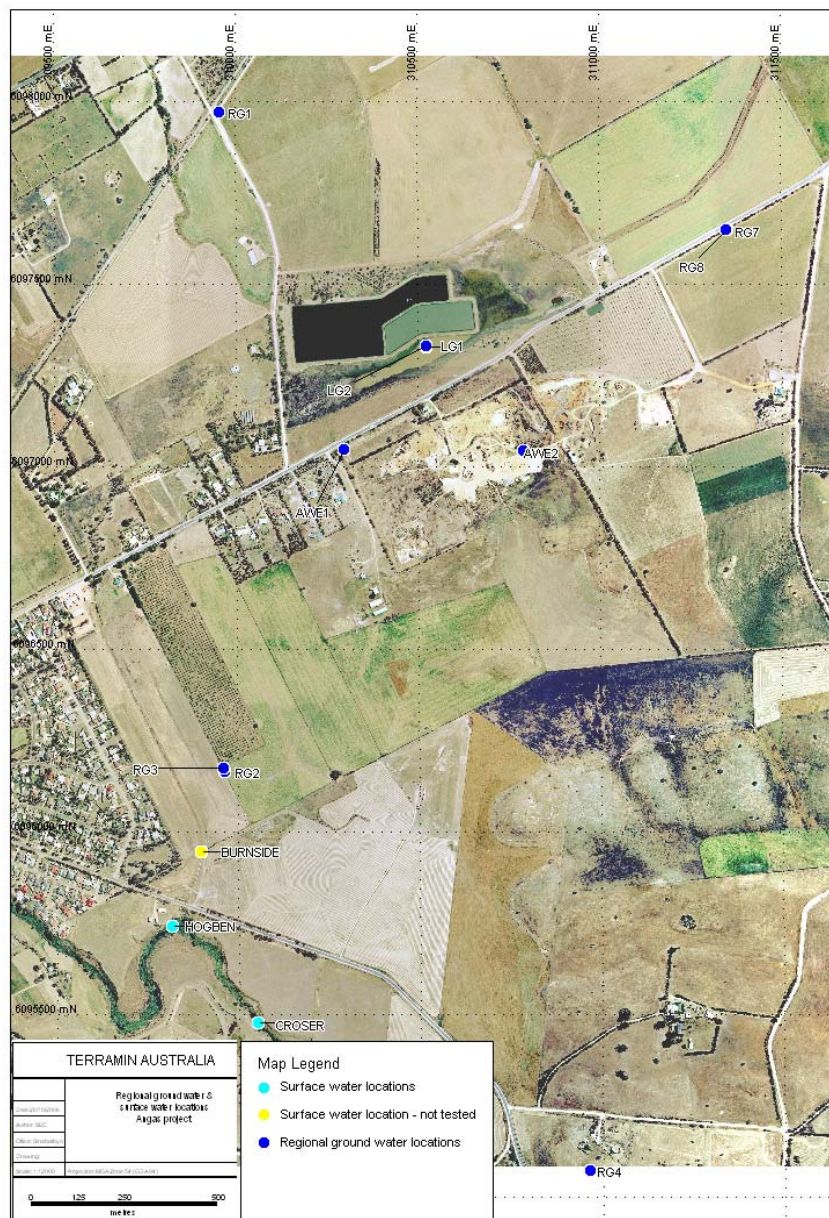
**Figure 1 Surface and Ground Water Monitoring Sites**

Table 1 and Figure 1 describe and show where the surface water sampling sites are geographically located. During this monitoring period surface water was sampled and analysed at two monitoring sites; at Croser and Hogben on the Angas River. There was no flow at the time of sampling in the Burnside Creek sites and at Croser on the January 2007.

Groundwater sampling sites monitored during period are presented in Table 3 below and shown in Figure 1.

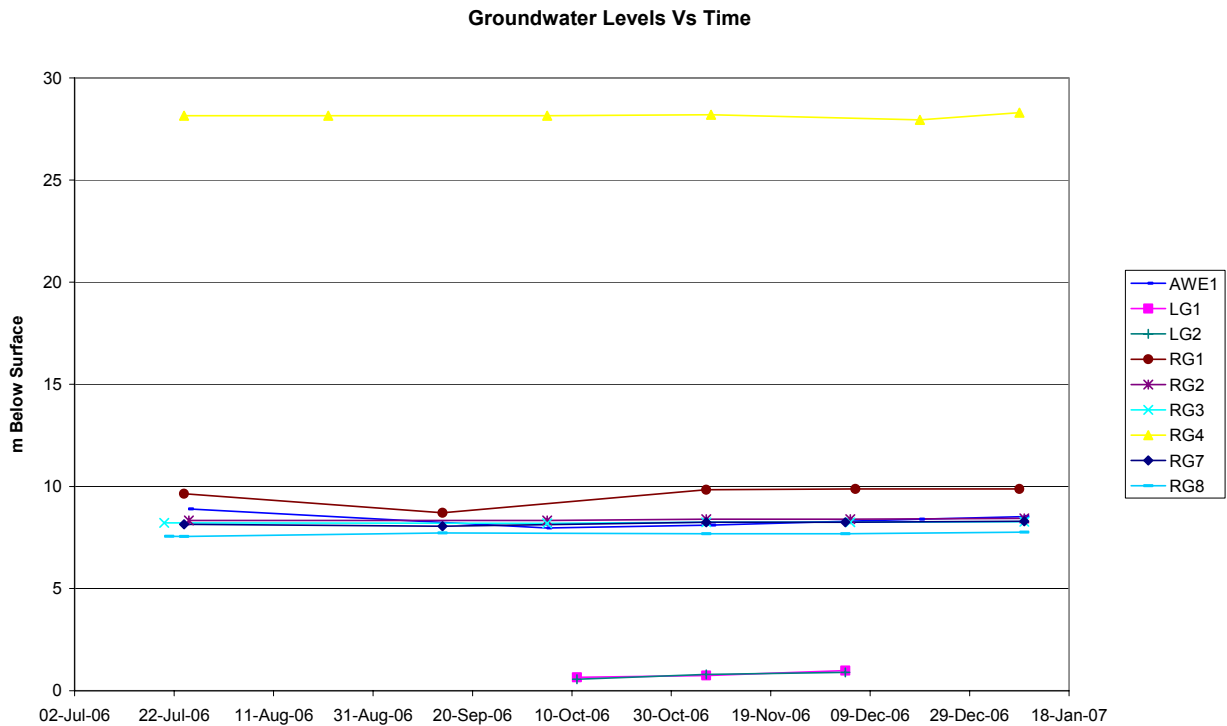
Figure 2 Groundwater Levels

The groundwater levels were plotted to evaluate seasonal trends, in Figure 2. These graphs show three water level groupings:

- Deep (between 27 and 29 m below the surface) at site RG4;
- Shallow, less than 1 m below ground level around the ponds (LG1 and LG2); and
- Intermediate, between 7 and 10 m below the surface at all other sites.

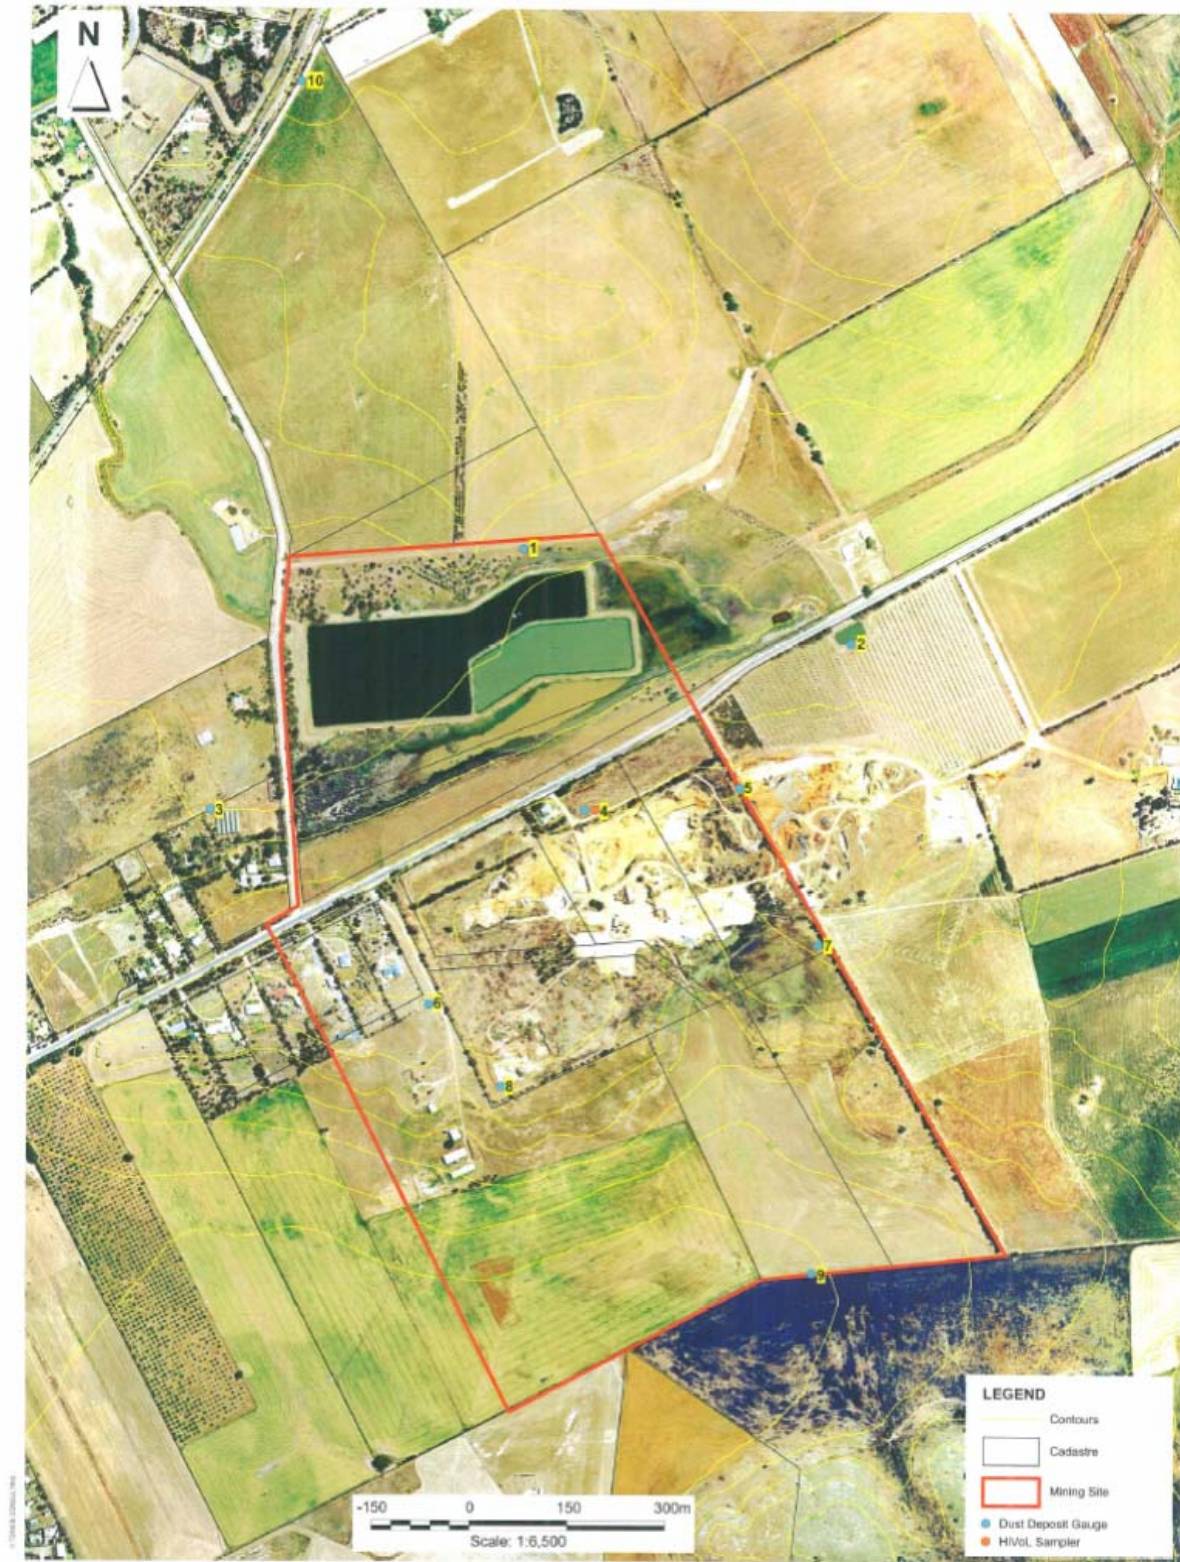
Figure 3 Dust Monitoring Locations

In the MARP Terramin proposed to implement several control measures to ensure that no significant dust from mining activities will leave the property. Terramin has been using two high volume samplers (HVS) located on the proposed mine site, to track Total Suspended Particulates (TSP) levels and ten dust deposition gauges (DDG) placed strategically around the property to establish a baseline for suspended dust prior to commencing mine operations. The dust monitoring sites are shown in Figure 3.

Deposition of lead bearing dust from mining activities has the potential to impact soil downwind of the mine. While there are no criteria for lead deposited in DDG, the criterion for soil lead content is 200 mg/kg. Terramin has been monitoring lead levels in dust collected by DDG gauges placed at ten strategic locations around the mine.

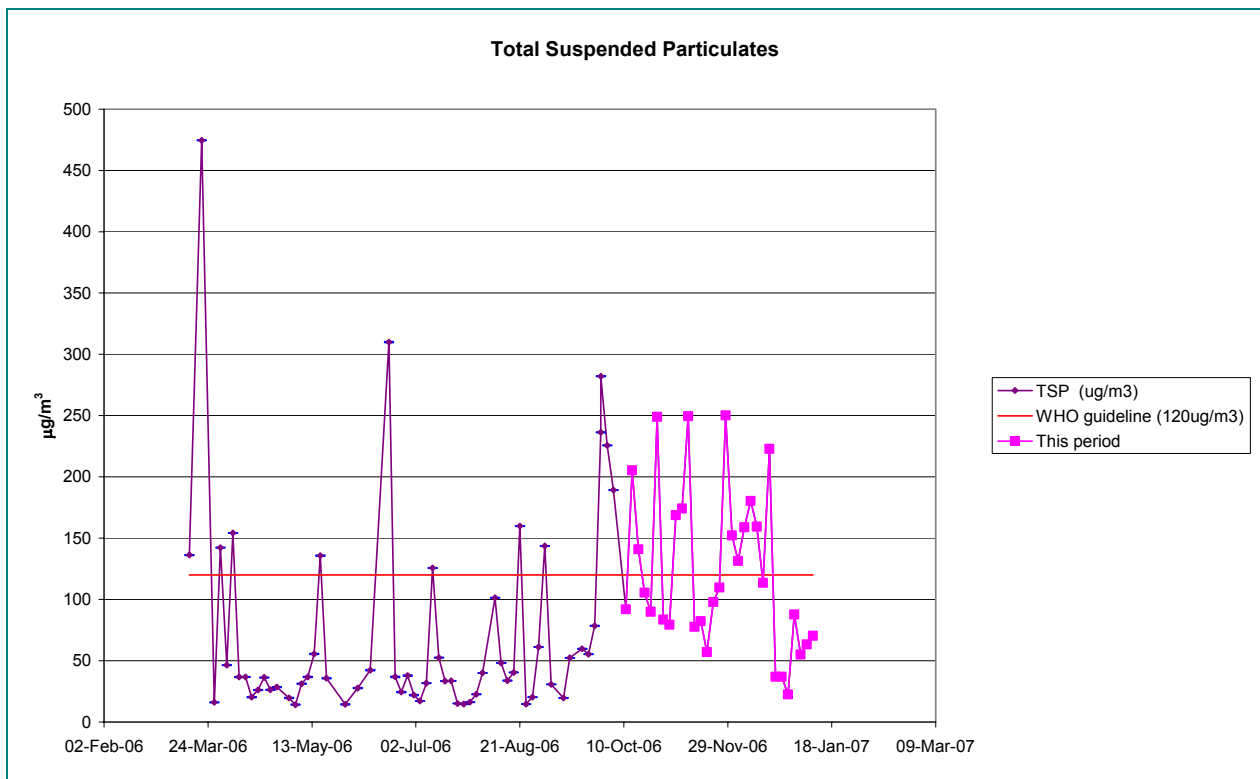
**Figure 4 Total Suspended Particulates**

The HVS results for this reporting period are presented in Table 6. All dust lead levels from the HVS were below the laboratory detection limit of 0.01  $\mu$ g/m<sup>3</sup>. A graph TSP levels since monitoring commenced in March 2006 is presented in Figure 4. Dust levels during this monitoring period are shown in pink.

The dust baseline data shows that the site can experience dusty conditions; this is not surprising since the property is currently used as a quarry and is surrounded by farms which at times generate extensive dust depending on the activities (e.g. cropping) or vegetation cover. Out of 31 TSP readings 1 was invalid (the HVS did not run for a full 24 hrs due to a power outage) and 13 exceeded the WHO health guideline value of  $120 \mu\text{g}/\text{m}^3$ . Anecdotal evidence suggests that this may be mostly attributed to increased extraction, crushing and transportation of quarry products from the site during this reporting period.

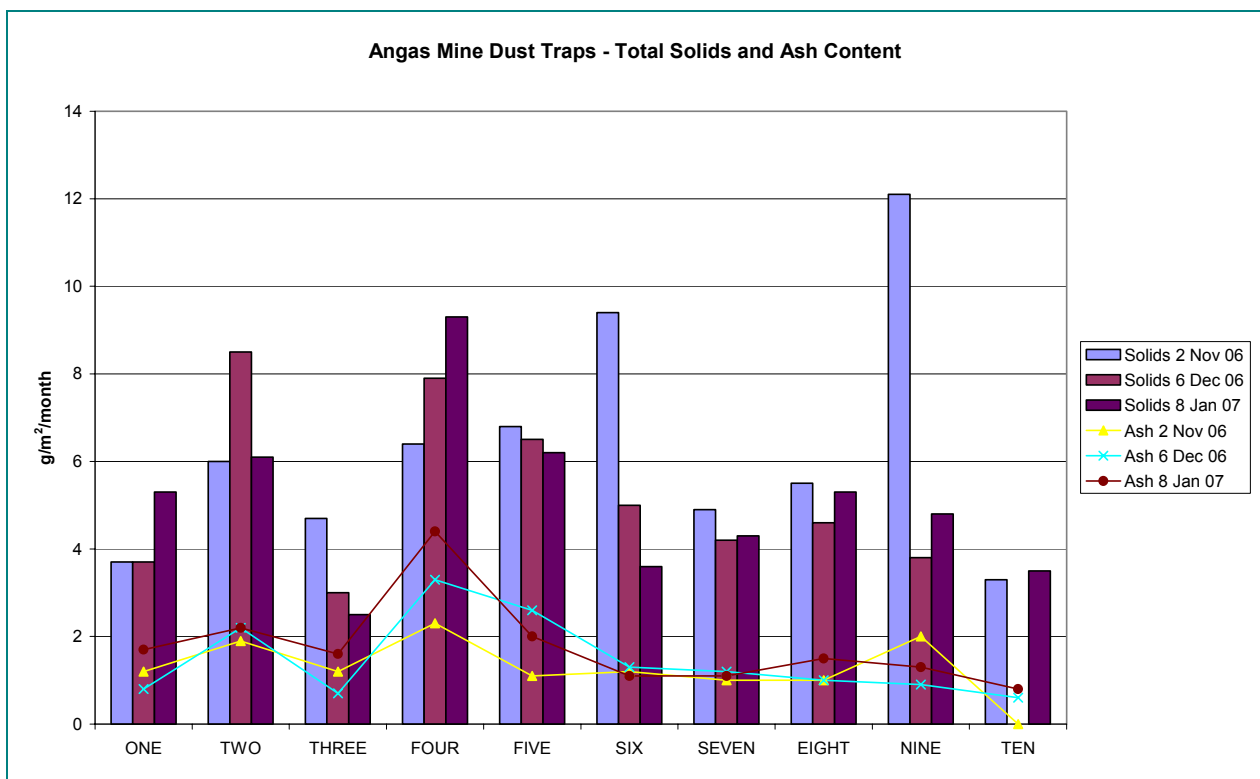
**Figure 5 Total Solids and Ash Content Deposited Around the Angas Mine Lease**

The laboratory results from ten DDG are presented in Table 7, total solids and the ash content is shown in Figure 5.

Dust deposition was generally evenly spread during this reporting period with one exception of high deposition at Site 12 in November 2006. There is insufficient data to determine trends or associate this with predominant winds.
