Quarter 4:2015

Strathalbyn Community Consultative Committee

TERRAMIN AUSTRALIA LIMITED

General Update

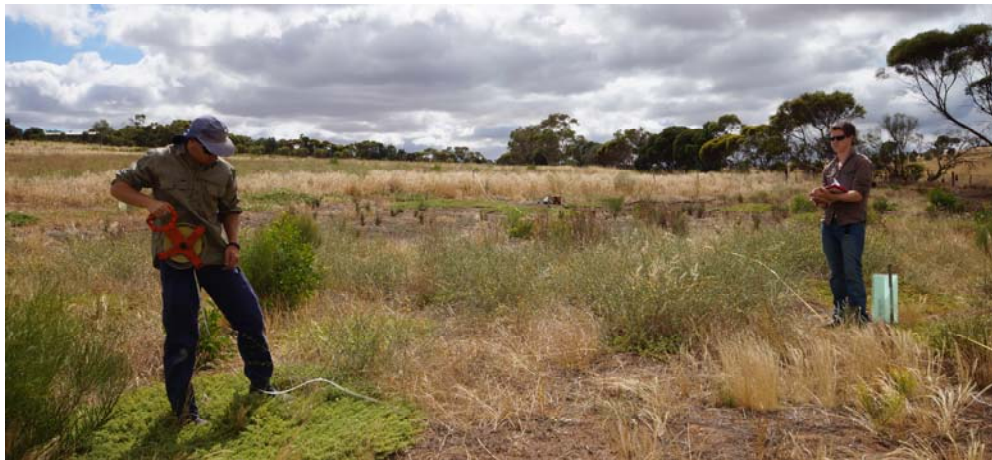
Flinders university students learning EFA techniques in the SEB areas in October 2015

- ▶ Ecosystem Function Analysis field work completed in November, report due early 2016
 - ▶ Early results indicate rapid growth of natives in Eastern SEB areas
- ▶ Rabbits and hares baited onsite with Pindone
- ▶ Annual Compliance Report due 31 March 2016

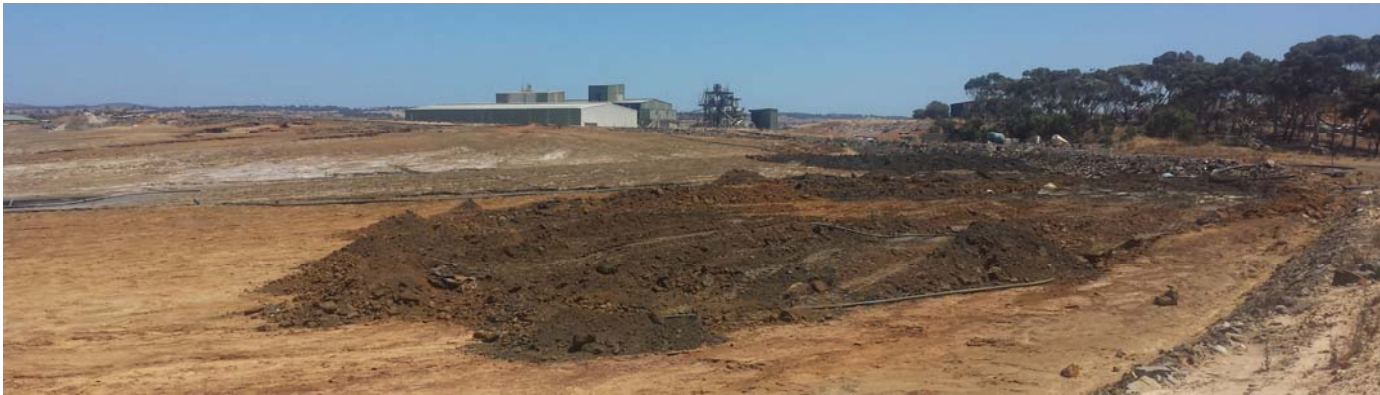
Spigot 6 Reduced

- ▶ TSF tailings reduced with excavator at Spigot 6 as recommended by ATC Williams in 2015 report
- ▶ ATC Williams will return for annual inspection on 23rd February 2016

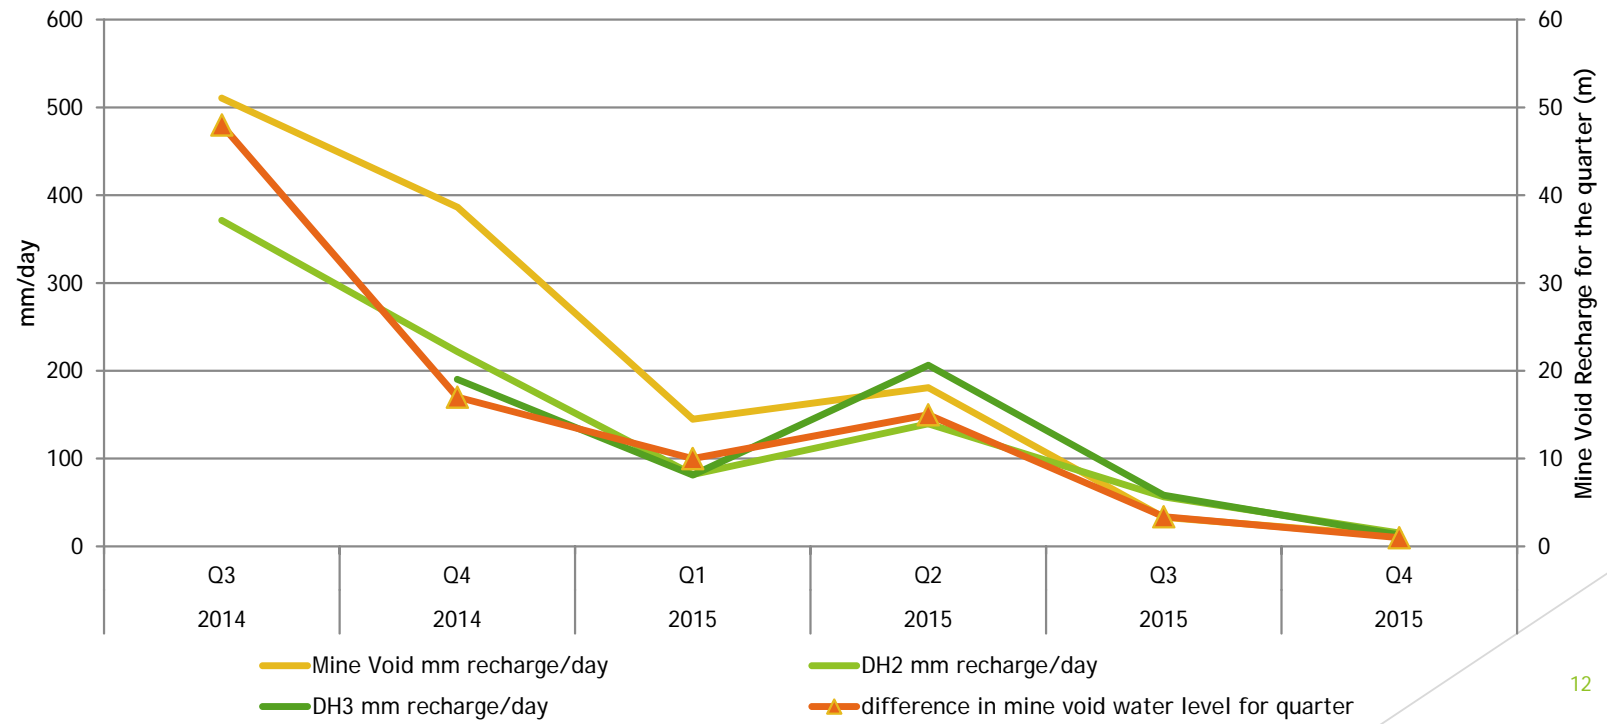
Estimated recharge rates (mm/day)

Mine Void Recharge - mm/day

- ▶ Recharge in the mine void, DH2 and DH3 over the recharge phase of the mine void
- ▶ Trends slowing dramatically as modelled

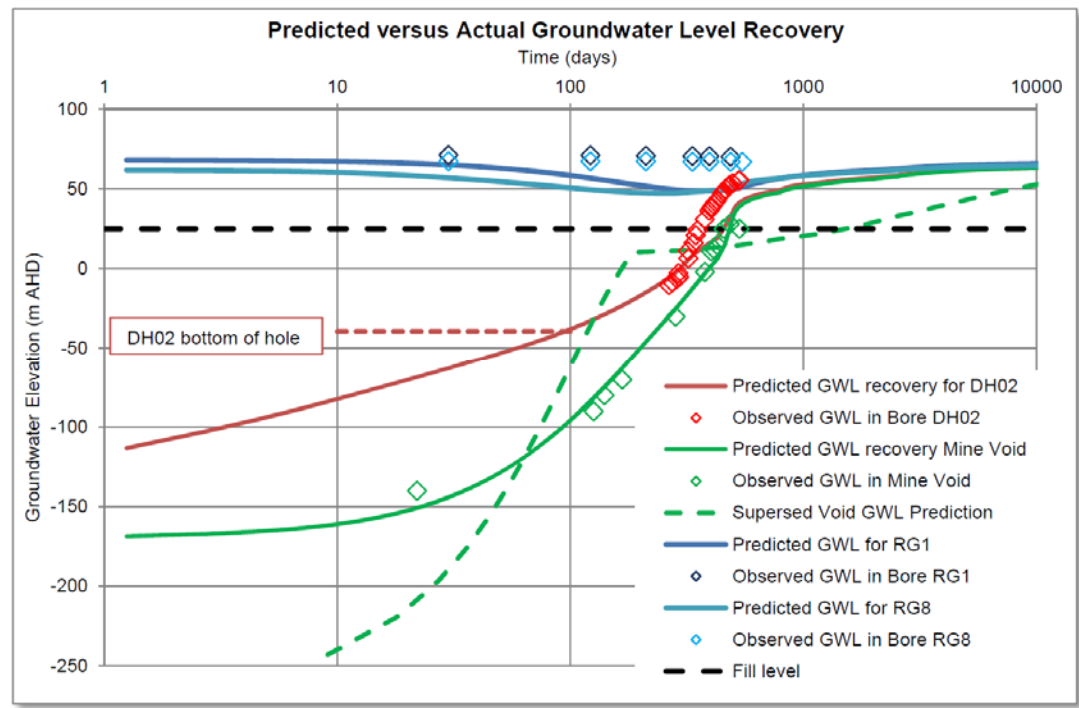
Mine Void Recharge - model recalibration

- ▶ Model recalibrated in 2015 with real data collected over past 18 months
- ▶ Matches real time trend demonstrated in recharge figures per day for mine void, DH2 and DH3 and per quarter for the mine void

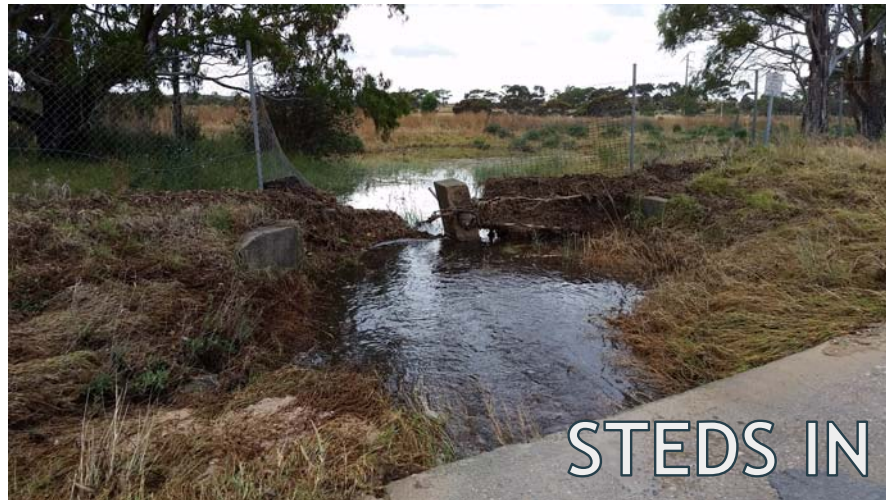
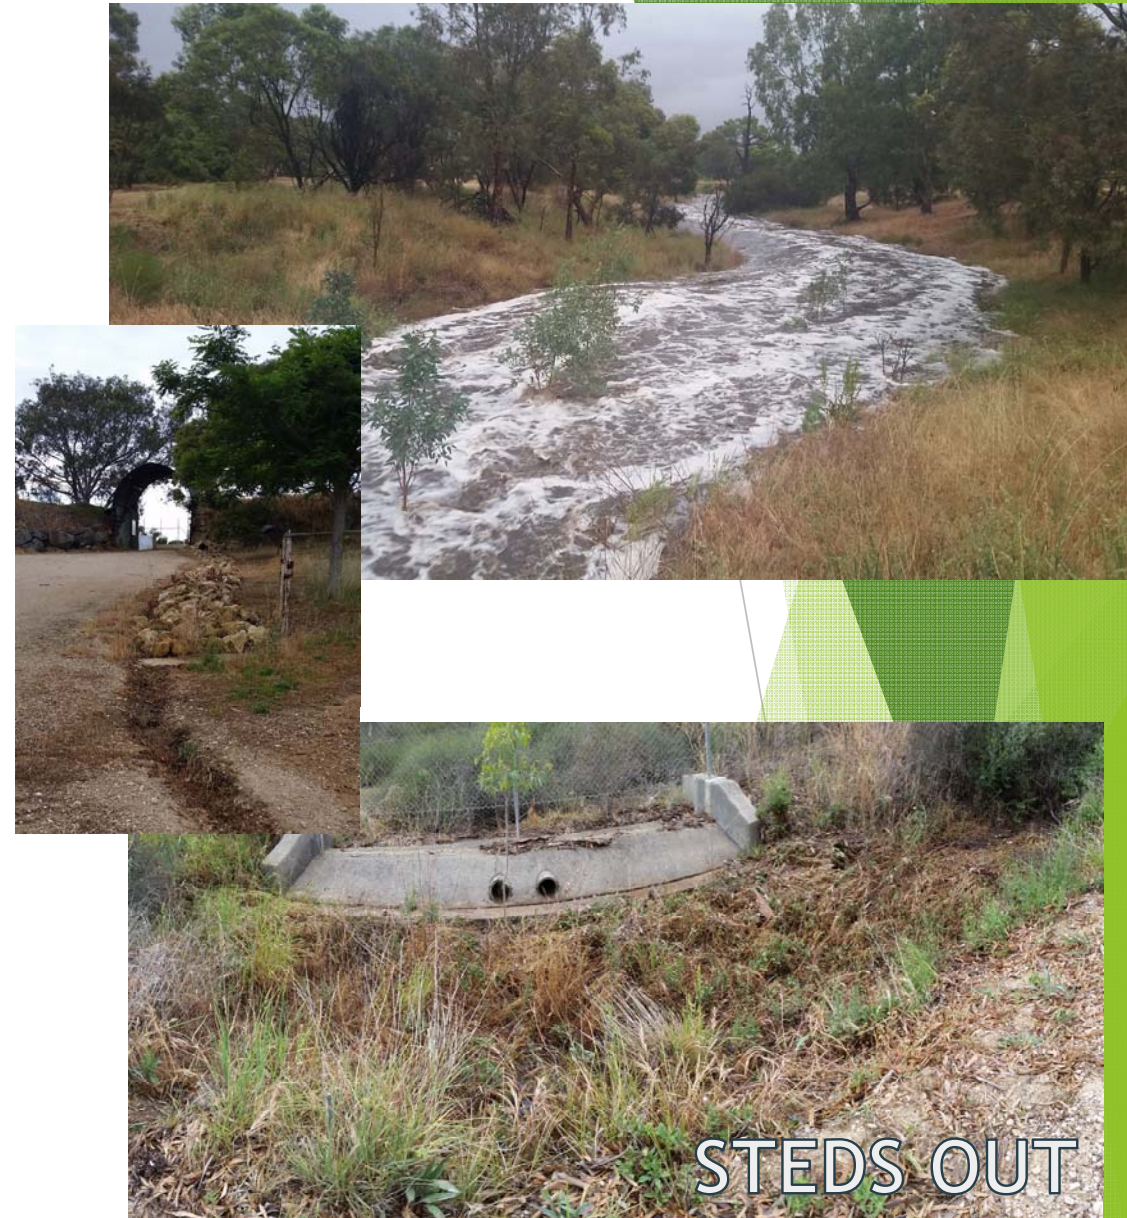
- ▶ Burnside Road Burnside Creek bridge - 6.40pm
- ▶ 34mm at Strathalbyn Post Office (BOM, 2015)
- ▶ 17mm at AZM onsite meteorological station
- ▶ 0mm at Summerhill Road, south of AZM
