Operations

1 year vegetation growth

Closure

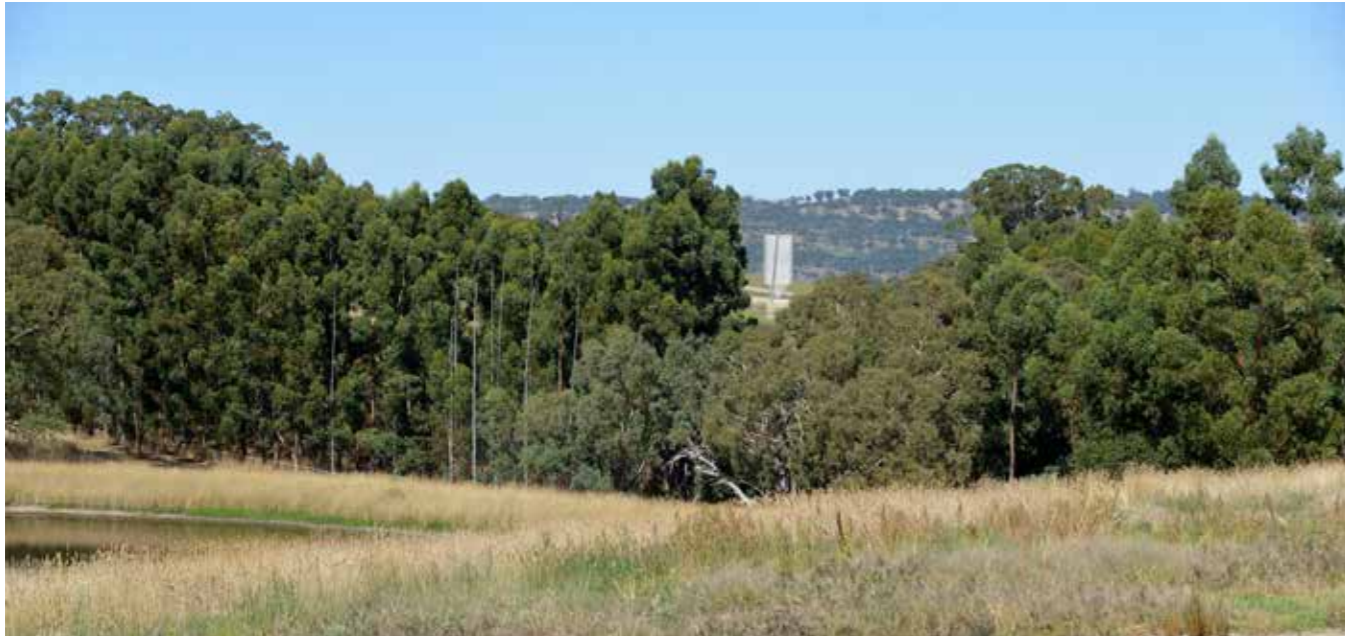
- Run of Mine silo visible above tree canopy
- Silo colour to be confirmed and shown for illustration purposes only
Final colour subject to community input
- Initial plantings established

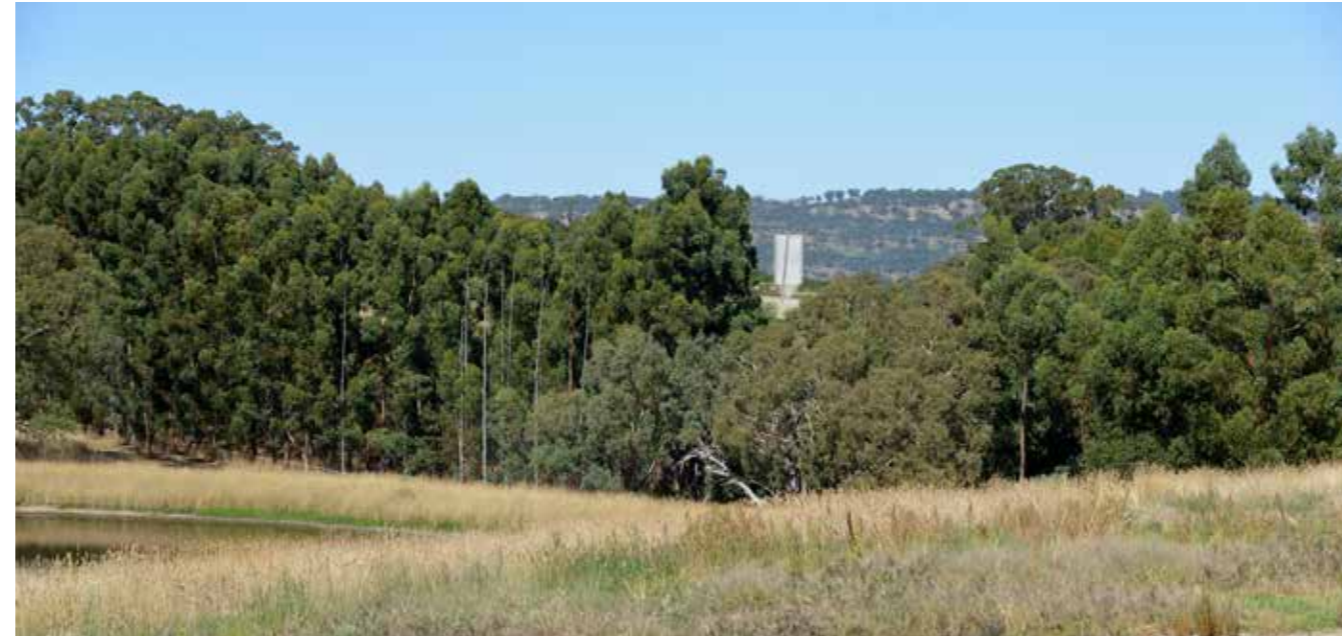
- Re-vegetation at perimeter partially obscures views into the site

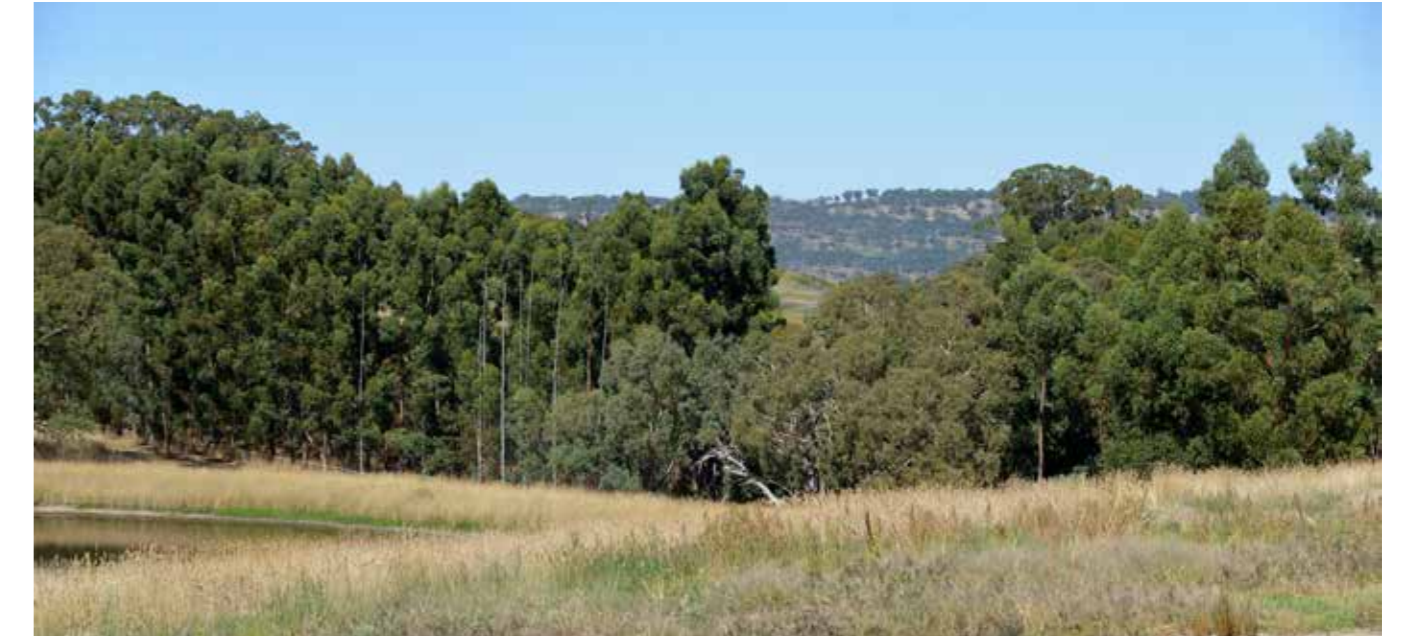
- Run of Mine silo is removed
- Native shrubs, ground-covers & trees established

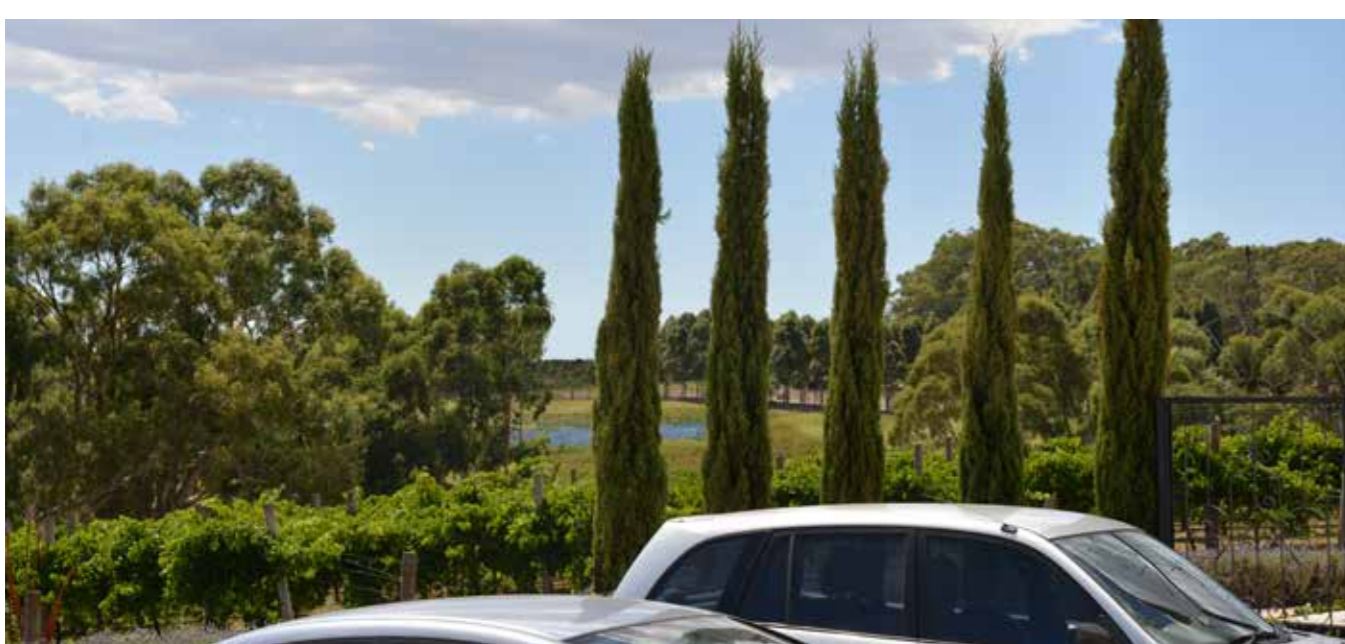
- Water storage dam and partial views of pump shed are visible
- Dam fringe planting and maintenance track partially visible
- Initial plantings installed

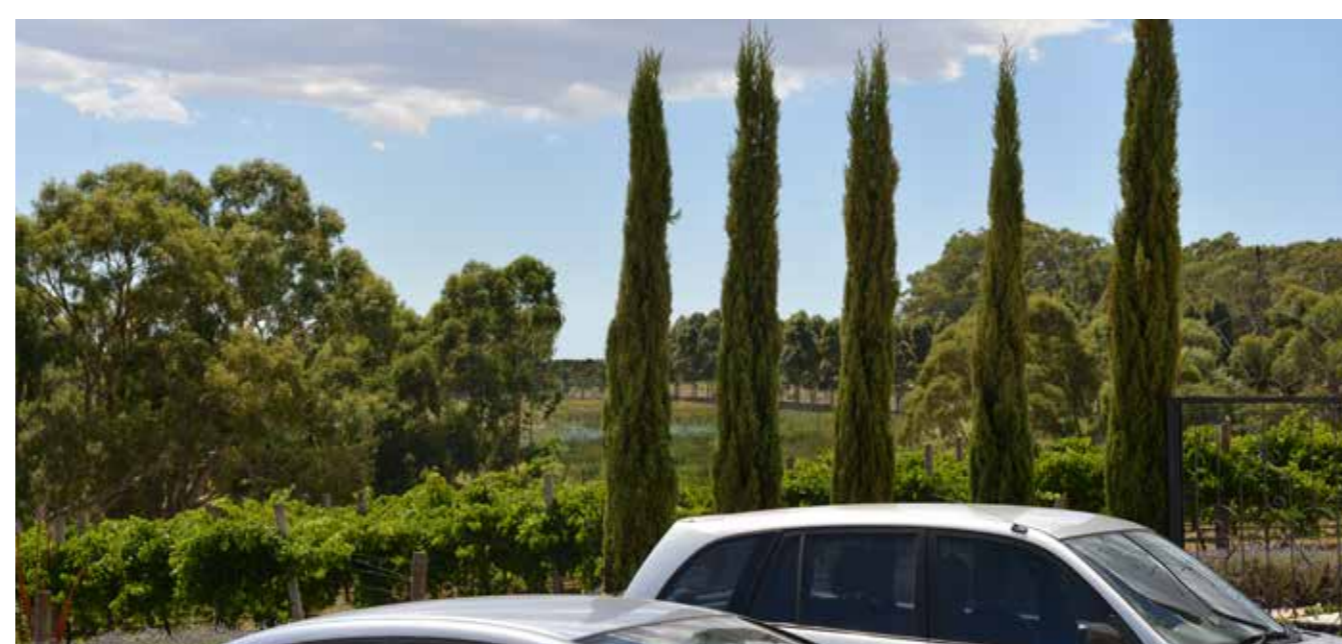
- Batter planting and adjacent re-vegetation partially obscuring dam edge

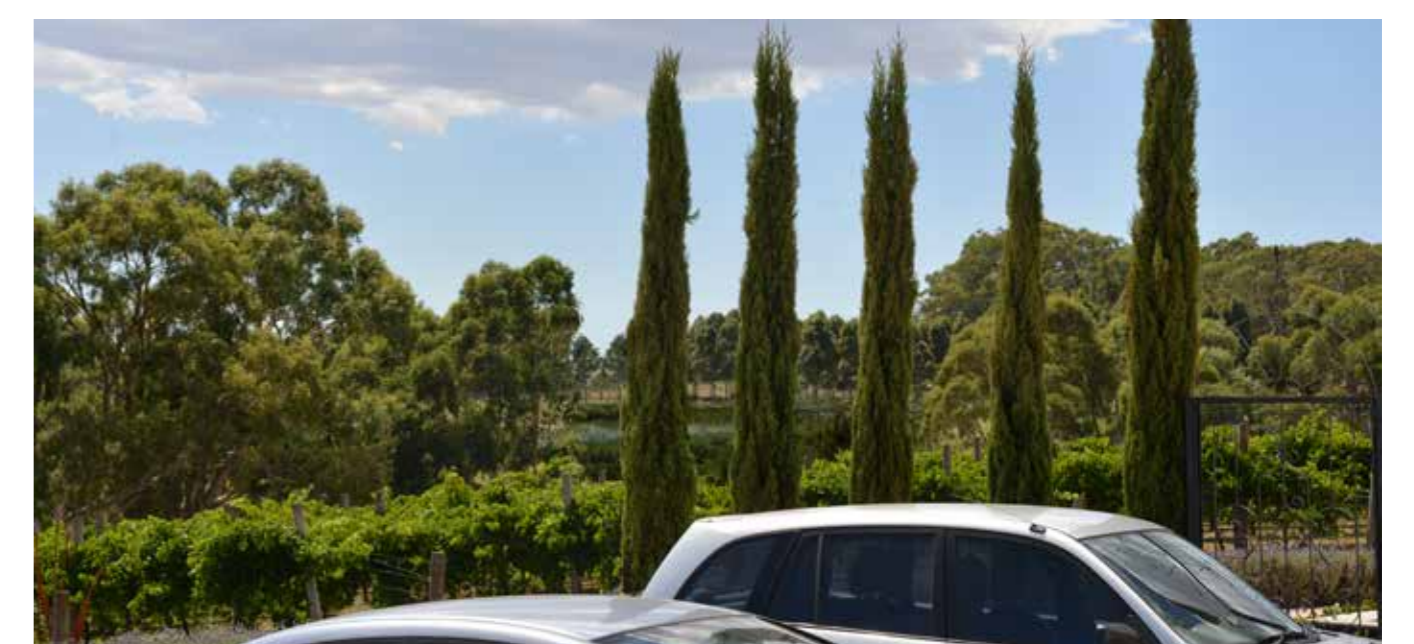
- Water storage dam with minimal water
- Native shrubs, ground-covers & trees established further

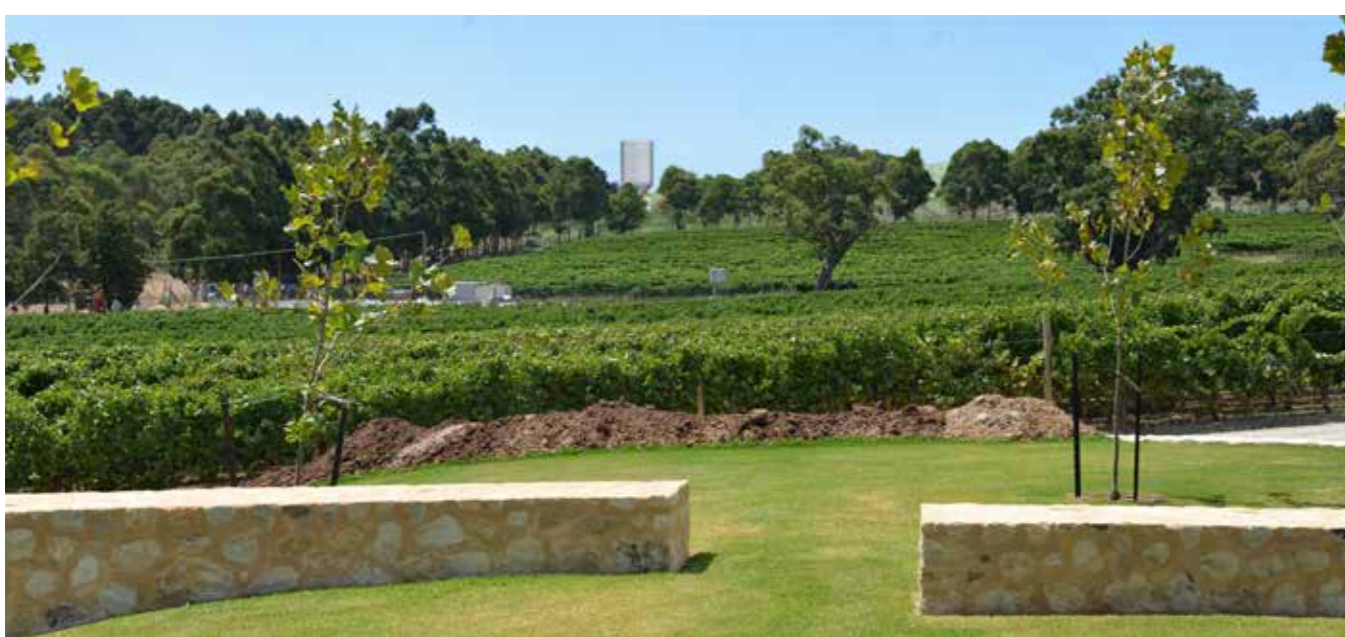
- Run of Mine silo visible above tree canopy
- Silo colour to be confirmed and shown for illustration purposes only
Final colour subject to community input
- Initial plantings established

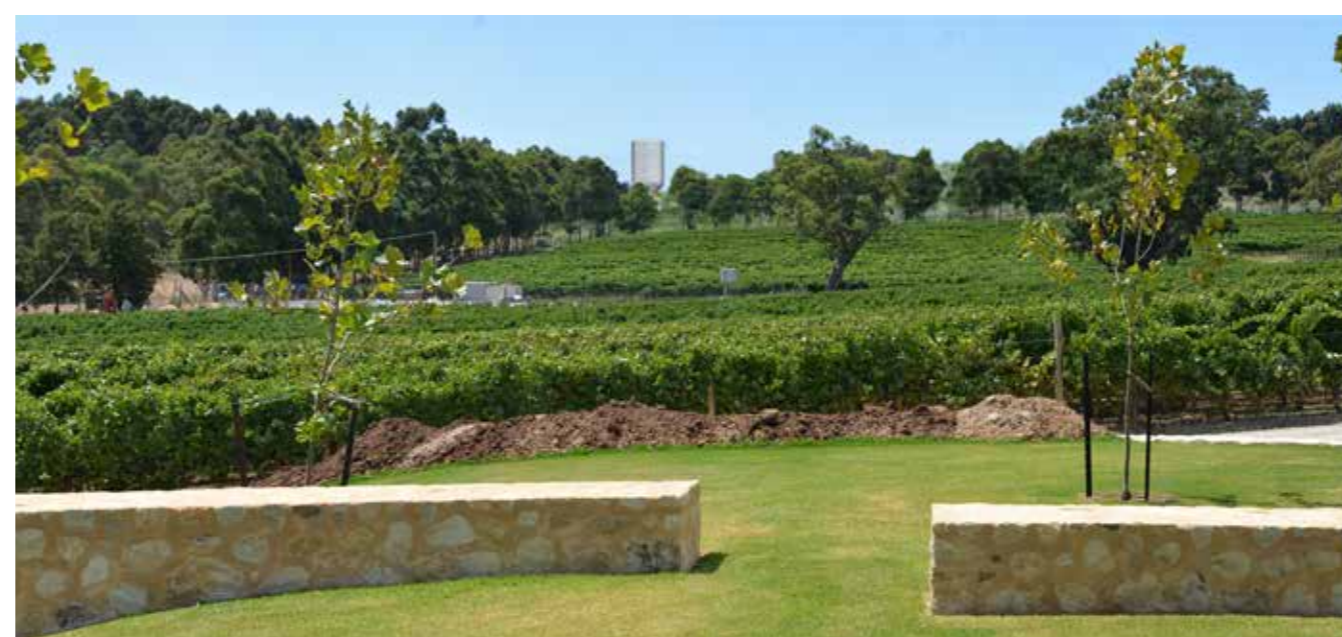
- Re-vegetation at perimeter partially obscures views into the site

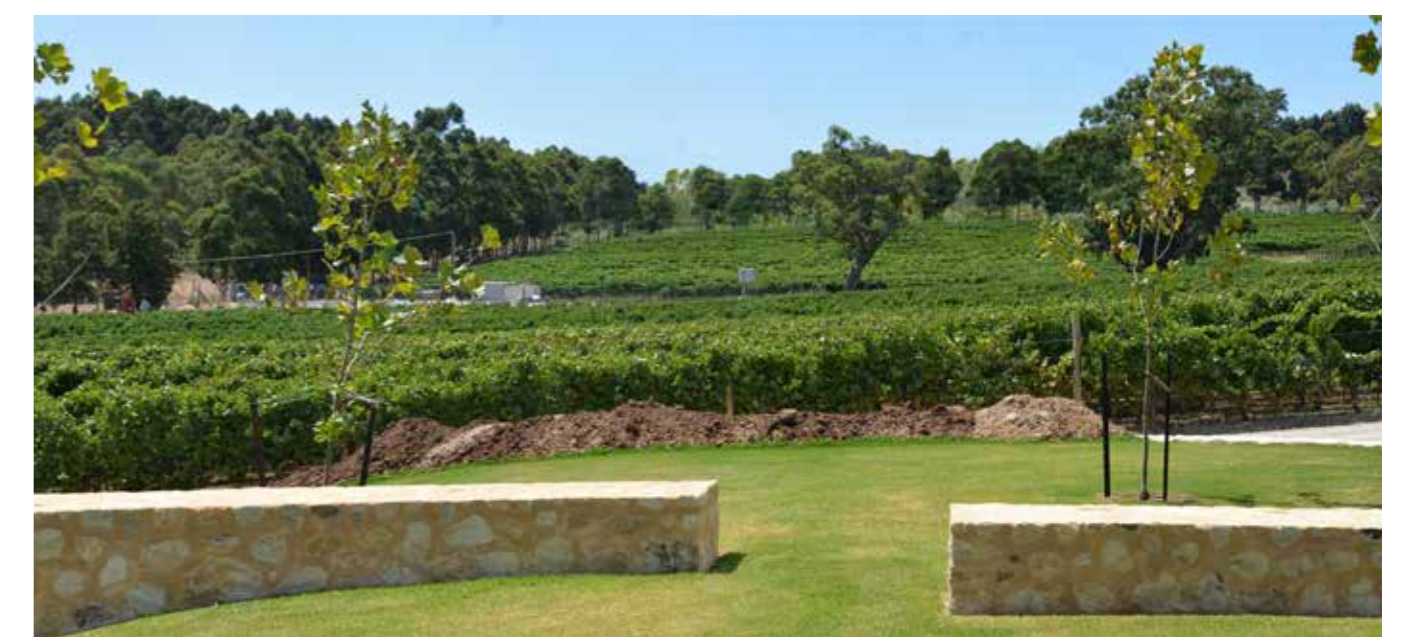
- Run of Mine silo is removed
- Native shrubs, ground-covers & trees established

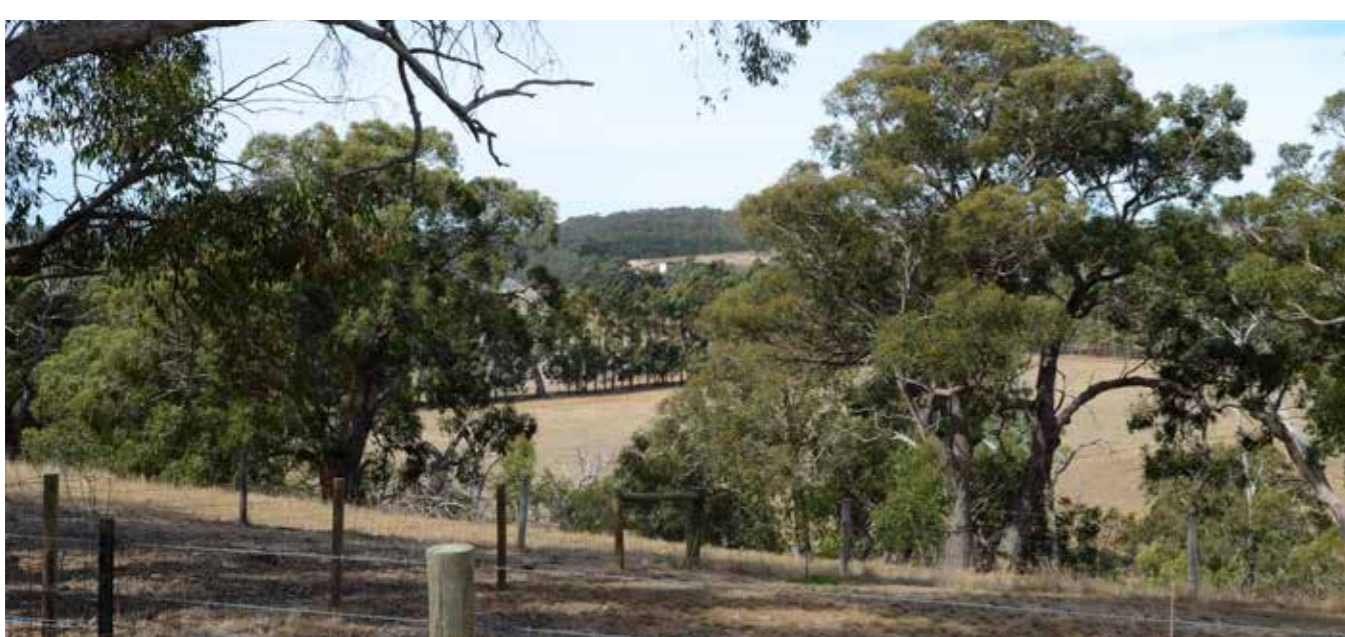
- Run of Mine silo visible above tree canopy
- Initial plantings established

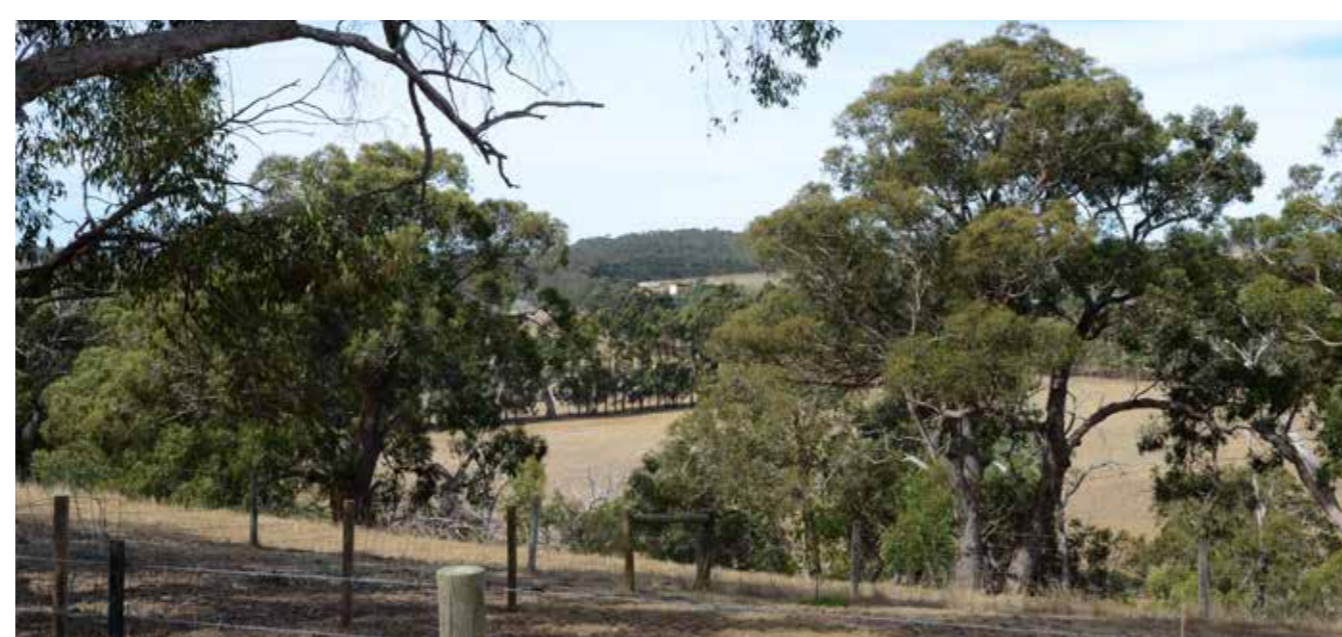
- Re-vegetation at perimeter partially obscures views into the site

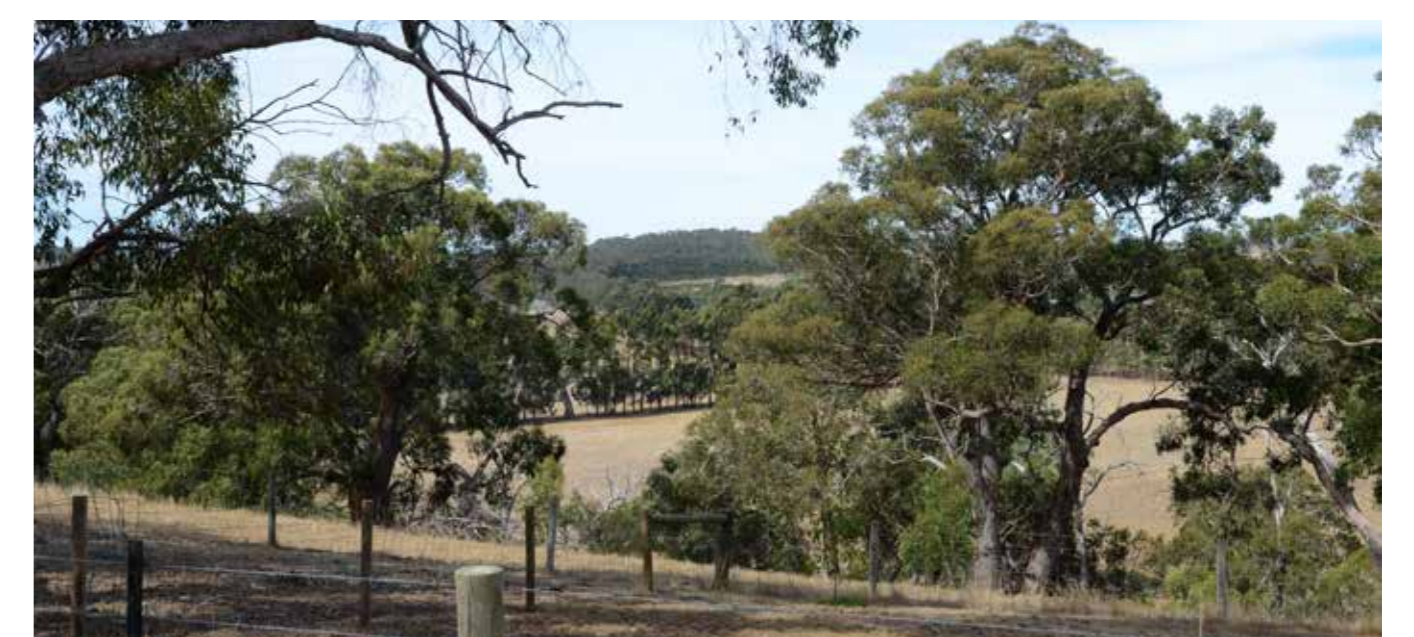
- Run of Mine silo is removed
- Native shrubs, ground-covers & trees established further

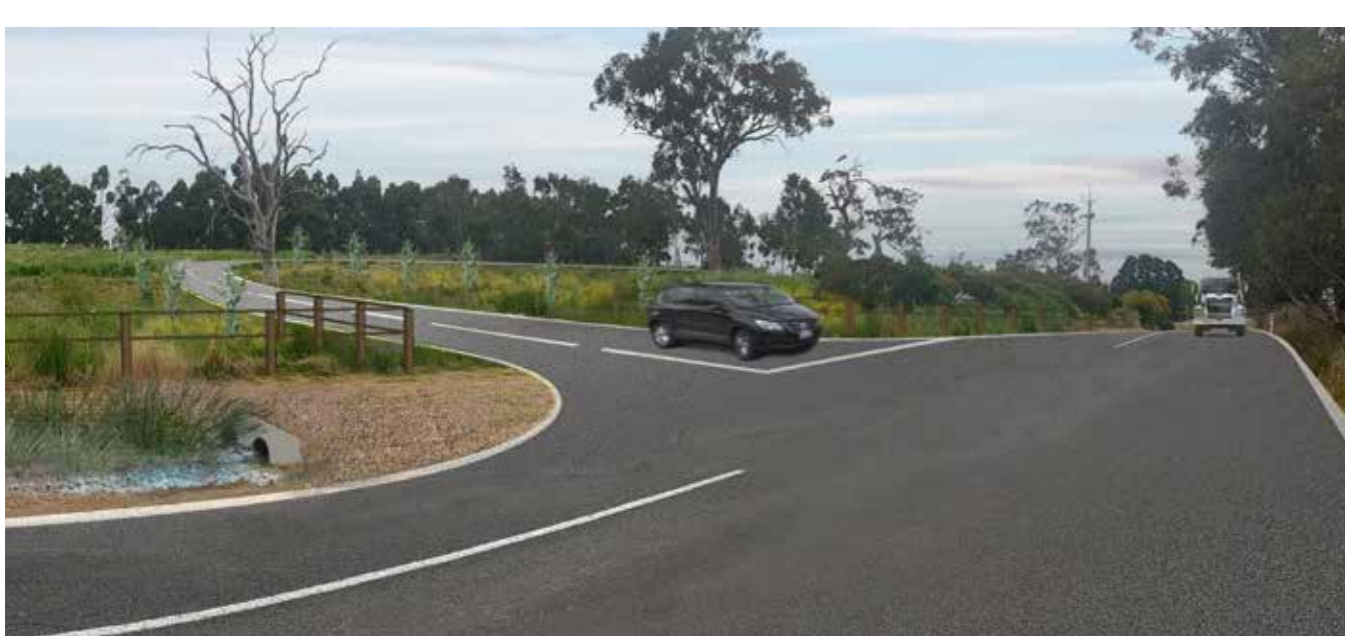
- Shade tree avenue established
- Initial plantings established

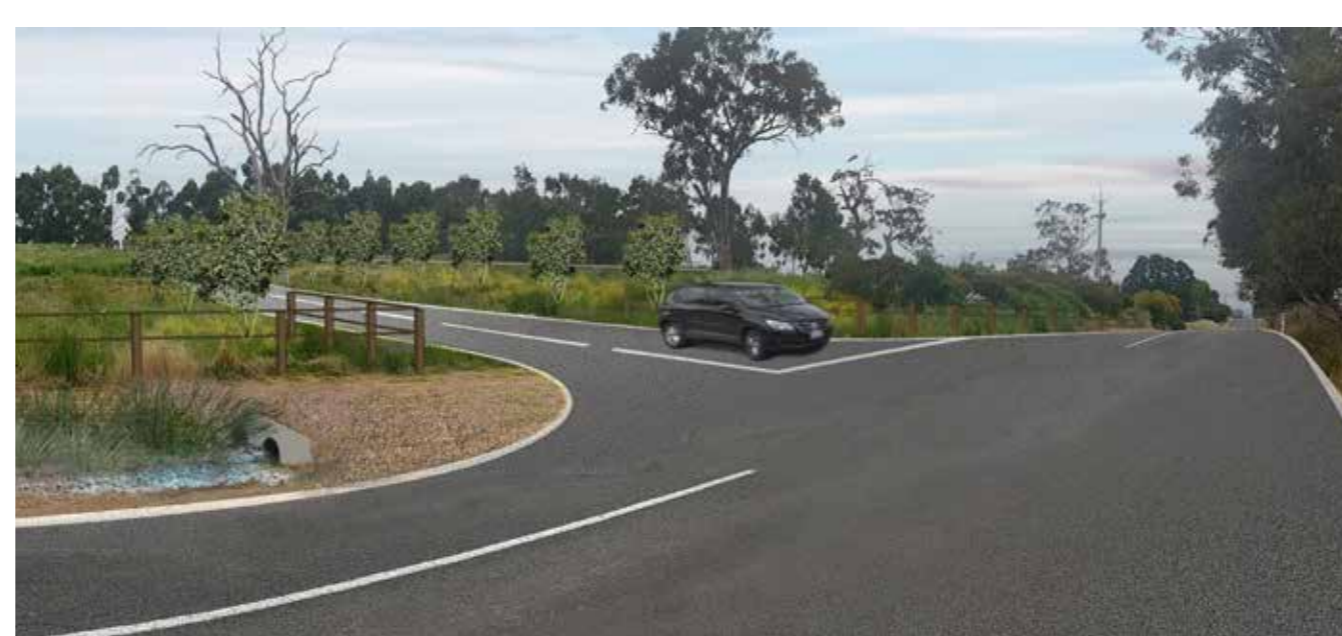
- Native shrubs, groundcovers & trees

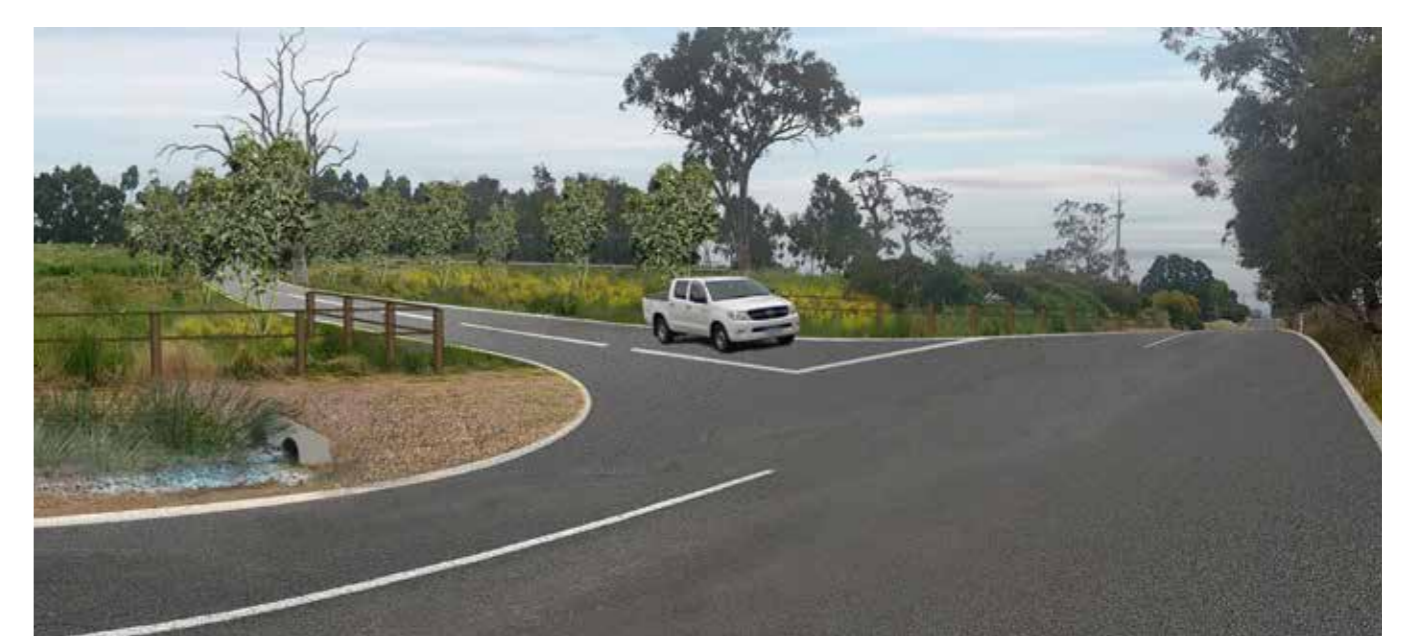
- Entry road and storm water infrastructure retained for future land-use
- Further tree growth
