### TAILINGS STORAGE FACILITY VEGETATION CAPPING TRIALS

# ANGAS PROCESSING FACILITY

Tailing Storage Facility - Rehabilitation Trials  
Annual Report 2 - December 2012

**Tailing Storage Facility - Rehabilitation Trials**

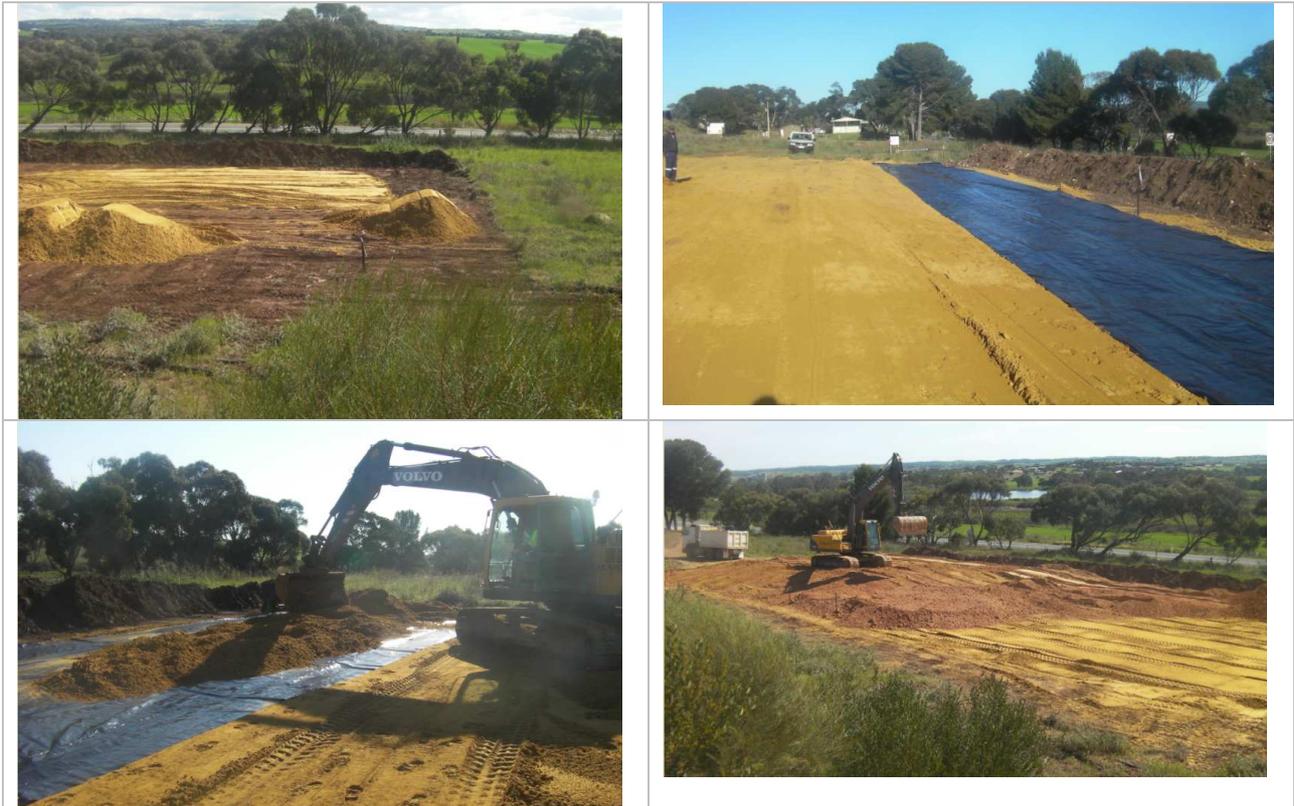
**Figure 3: Tailing Storage Facility - Trial Covers Construction Sequence**

A pictorial record of the construction phases is presented in Figure 3 showing site preparation, placement of the PVC liner sandwiched between two layers of sand, covered by two subsoil treatments (~600 mm and ~1,000 mm) and 100 mm of topsoil. Figure 4 shows the completed landform and the installed soil moisture sensors prior to plant emergence.

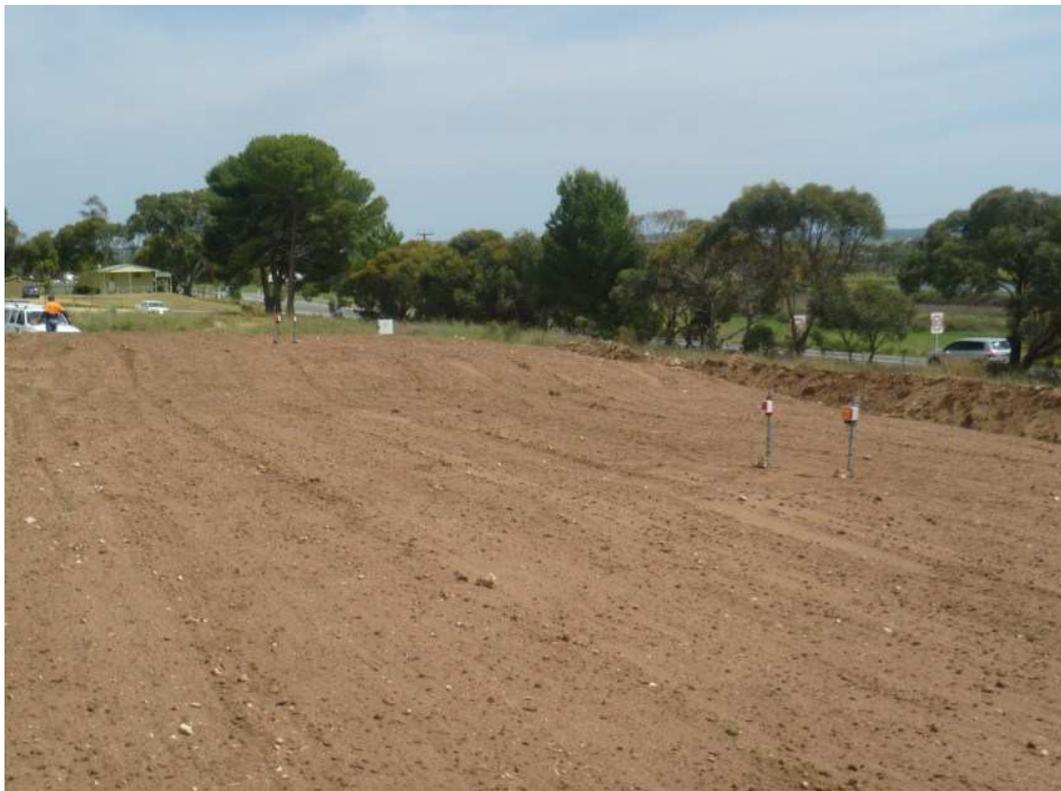
**Figure 4: Rehabilitation Trial Covers – 2011**

\* High profile and 2 soil moisture sensors in background and sensors on low profile in foreground.

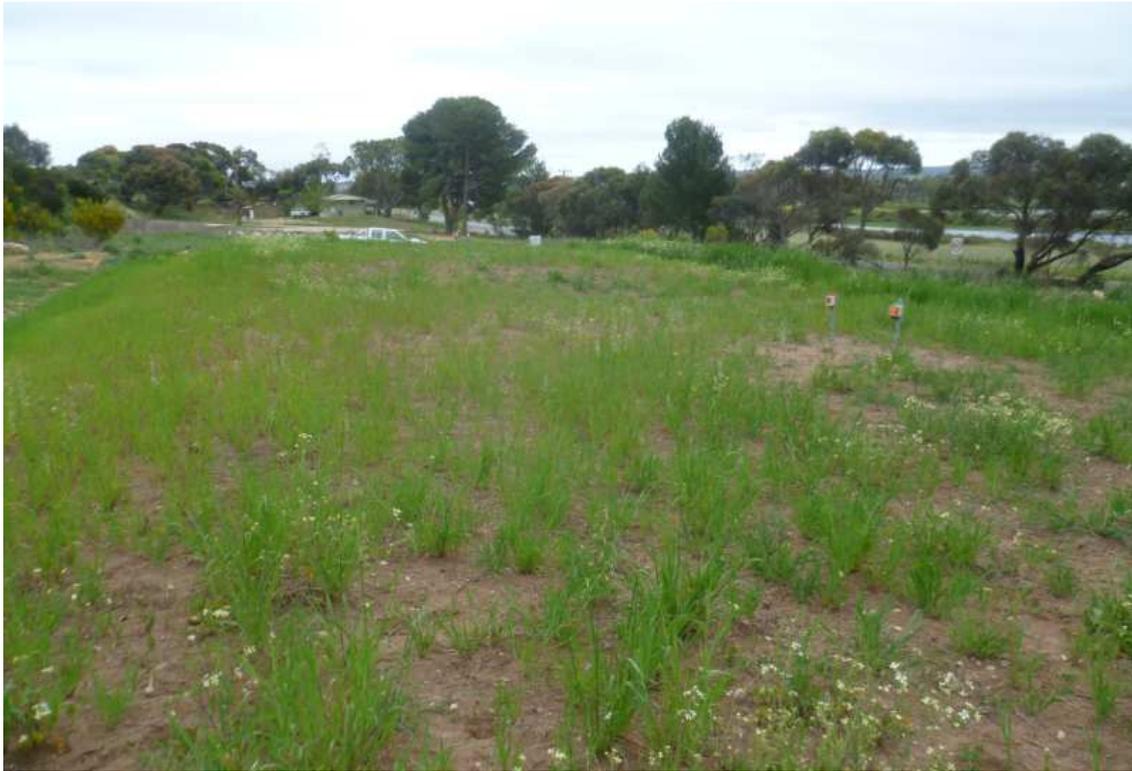
**Figure 5: Plant Germination - 5 October 2012**

A good even germination of oats was observed on the shoulders, but the native grasses on the top of the trial had much lower germination rates. A vegetation cover was established on top of the trials consisting mostly of self sown Saia oats and weeds, Figure 5 taken in October and Figure 6 taken in December prior to harvesting.

The native grasses did not establish well on these trials, the reason is not known; however self sown Saia Oats from the previous season established and covered most of the trials as shown in Figure 5 and Figure 6. This demonstrates that a sustainable vegetation cover can be achieved on both cover treatments. The average vegetation ground cover for each of the main species observed was calculated and plotted for each treatment, Figure 14. Some native grasses were recorded but represented around 0.5% of the overall vegetation ground cover. The main weeds observed were, Wire weed (*Polygonum arenastrum*), Twiggy turnip (*Brassica fruticulosa*) and Couch grass (*Cynodon dactylon*).
